# Bloodhound News

Issue 3 – October 2013

# LCP and T86 Restoration - Update

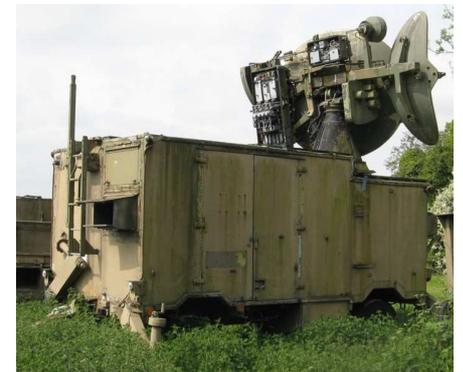
BMPG's Radar Type 86 before recovery

The above photo shows the condition of the T86 before recovery. Note: The two covers on the rear of the Aerial Assembly have now been replaced. The missing on-launch reference aerials, on the corners of the cabin, have also been replaced.

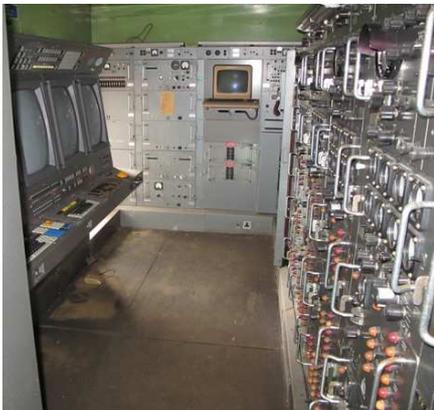
IWM Duxford's MK2A LCP

The LCP is complete with no missing

items or units, unlike the BMPG LCP which had the E.C.'s keyboard and top switch panel missing from the console. Internally the LCP is in good condition but not surprisingly it needs a good clean.

The main purpose of the visit was to photograph and document the E.C.'s keyboard in the LCP as it is the only UK variant of the keyboard that remains. The BMPG's LCP has a Swiss E.C.'s keyboard as the original keyboard was missing when the LCP was acquired.

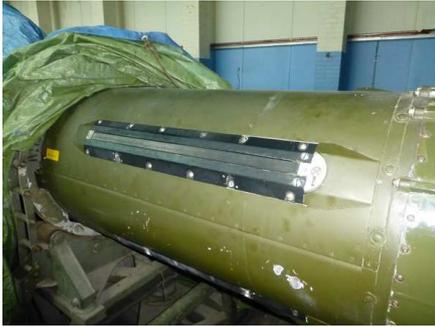
Fuze Aerial on BACT's MKII Missile

Recent work on the missile has involved refitting the fuze aerials to the fore body, the aerials being kindly donated by the Swiss BL-64 museum. It is

believed that this missile is the only one in the UK to have fuze aerials fitted.

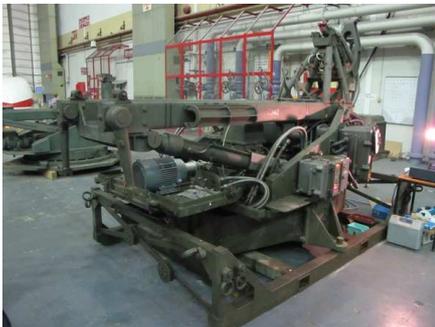
BACT - MKII Type 202 Launcher

The BACT purchased their MKII missile and launcher from MOD at the end of Bloodhound in the UK. The launcher had been stripped of all its assemblies (as had their MKII missile), power pack, hydraulics etc. The launcher looked the part but all the attached assembly boxes were empty. A year ago a full set of launcher assemblies were donated by the Swiss BL-64 museum, the assemblies were surplus and destined for scrap. Over the past year Brian Blestowe of the Bristol Aero Collection Trust has been re installing the missing assemblies to the launcher with the objective of restoring the main electrical circuits and the hydraulic system.

In the above photo; note the illuminated bulbs in the 'Fault Locating Indicator Assembly', power on!

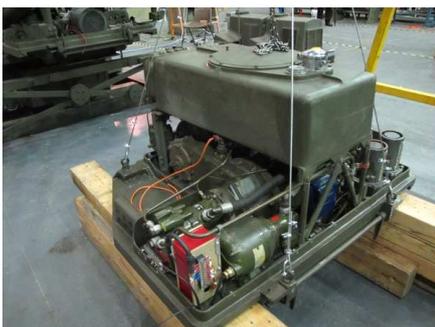
MKII Launcher - Hydraulic Pumping Unit

The Hydraulic Pump Unit has been removed from the launcher for refurbishment work to be undertaken on the main structure and hydraulic lines within the launcher. The Low Pressure Pump has been operated temporarily and consideration is now being given to renewing the hydraulic fluid before progressing further.

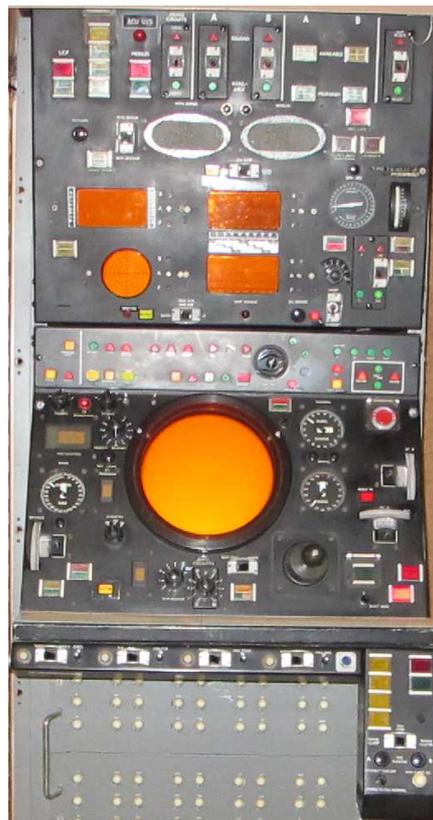
MKII – Original E.C. Console

The following photograph is of the early version of the MKII console at the BL-64 museum.

Help is currently being sought by the Bristol Aero Collection Trust to restore their original MKII E.C. console. An initial survey is required to determine if anything demonstrable can be returned to the console, even if it is just indicator lamps. If anyone is able to help, please email [contact@bmpg.org.uk](mailto:contact@bmpg.org.uk).

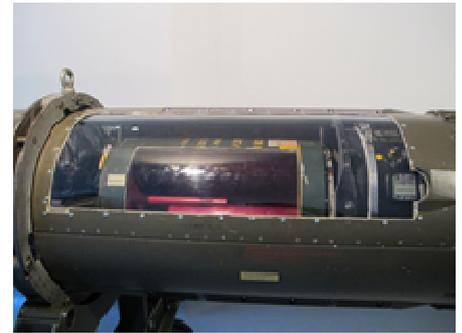
Following on from Part 1 and 2 in Issue 2, two further photos now complete the series that show a sectioned MKII missile.

MKII Missile Warhead and Fuze

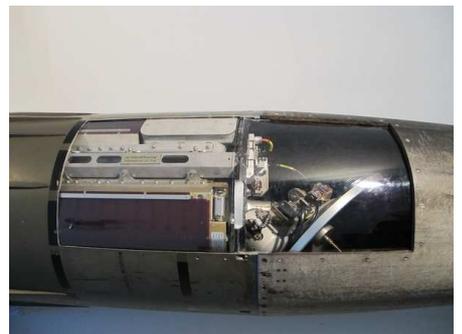
MKII Missile Electronics and Guidance Pack

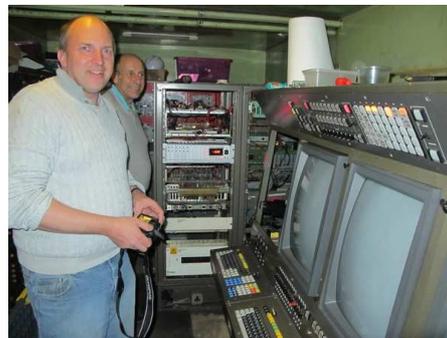
Display Console 'Lamps On'  
Richard Vernon and Neil Cartman

LCP restoration at RAF Cosford remains focused on the computer racks and display console to reinstate the simulator. Currently, a staged application of mains power to the computer racks and display console is under way.

The current task is to ensure as much of the computer racks, of which there are two, and the display console is working before the Argus 700 is reinstalled.

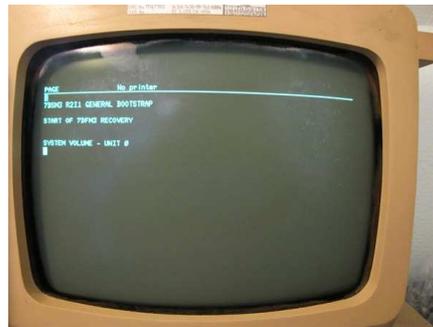
FT81 Terminal  
Connected to the Argus Test Rig

In Issue 2 the Argus 700's FT81 terminal had the official status of 'nearly repaired'. It can now be reported that the FT81 is serviceable once more, thanks to the efforts of Mike Strange who battled away to get it working. To make the FT81 serviceable a replacement video board was required, a replacement board was kindly donated by the Swiss BL-64 museum. Once repaired the FT81 was connected to the Argus 700 test rig and failed to display anything from the Argus 700! This non-fault was down to not wiring a link in on the 15 pin D Type socket on the RS 422 cable from the Argus 700. After repair the FT81 ran its internal test routines so all was ready to go. Well almost.

Initially all was going well with the FT81 but after a period of use the FT81 became unreliable. One FT81 test allows a key press repeat on the screen and key presses would work initially but then stop. The fault was eventually found to be a CMOS device on the keyboard which was replaced. The FT81, with its keyboard operating correctly, is now connected to the test rig and working correctly.

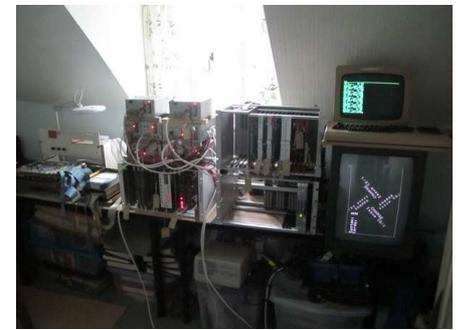
Argus 700 Test Rig

The above photo shows the test rig in action with displays on the FT81 monitor and on a console display monitor, (borrowed from the LCP). The angled text display on the console monitor is giving the firmware version number from the display controller card, this happens when the CHARGE display cards are not being driven by the Argus 700. All four of the console monitors have been tested by connection to the CHARGE chassis in the test rig and all four give the same display, so are assumed serviceable!

So far testing has been carried out on the Digital Input and Output Cards and these have now been re installed in the LCP.

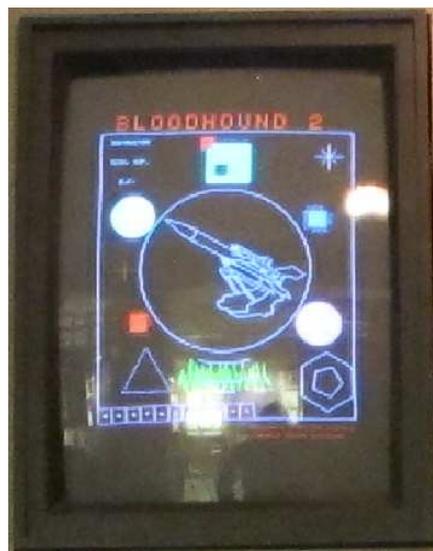
Bloodhound MK2A Boot Screen  
(Apologies for the glare)

Unfortunately it has been established that the software halts with errors if only a single display channel is connected, two channels is a minimum.

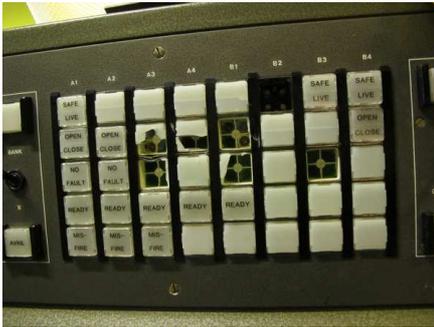
Section of Recovered Top Switch Panel  
(Original Condition)

The top switch panel installed in the BMPG's LCP was recovered from a derelict LCP (Ser. No. 1006).

Most of the damage to the top switch panel has been repaired, including the re soldering of broken wires and replacement of the two speakers (comms and aural doppler). The top switch panel has been refitted to the display console in preparation for testing. Several lamp covers still needing to be replaced.

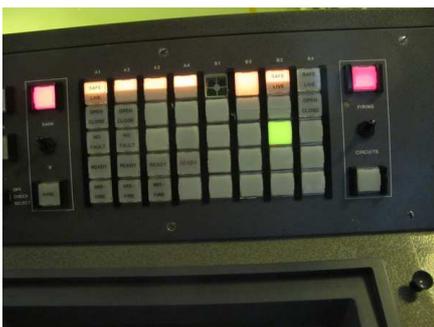
Missile 7, green 'No Fault'  
It should not be on!

One of the first tasks in carrying out a staged power up of the LCP was to reinstate the -24 Volts DC lamp power supply in the display console and press the Test Lamps button. Surprisingly most of the 28V pea bulbs used in the indicating lamps still worked. Unfortunately one set of lamps were 'on' when they should be 'off', namely the No Fault indication for Missile 7. Initial fault finding shows the fault to be within the top switch panel itself rather than any external unit. The top switch Panel will now be removed from the LCP on the next working day. It is a case of then finding the short that is providing the earth path for No Fault on Missile 7.

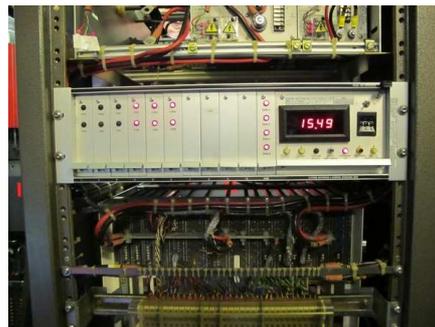
Power Supply Monitor & Interlock (PSMI)

The role of the PSMI is to monitor the DC power supplies in the computer racks and display console. If a power supply fails then the mains input to all DC power supplies, apart from those supply the Argus 700, are switched off by the PSMI.

To achieve a staged power up of the computer racks the PSMI has to have its override switch on. As can be seen in the above photograph only six of the twelve voltages being monitored are present.

All didn't go smoothly with the PSMI. It operates correctly but the Digital Volt Meter gave no readings. The original was replaced with a spare and the

replacements PSMI is shown in the photograph, with a working DVM.

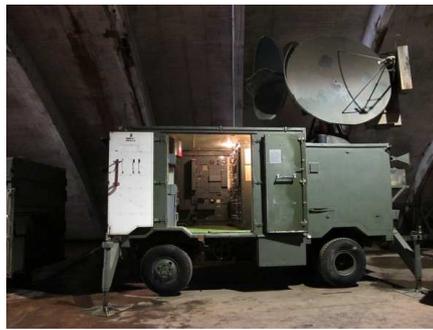
BMPG's T86 Ser. No. 501

An initial survey of our T86 showed that while its exterior condition had suffered the ravages of time from being kept in the open, corrosion was not serious. There were also some initial concerns over what damage may have occurred and what items equipment may have been removed from the T86. Such fears were mostly unfounded.

The main corrosion problem was found on the lower section of the roof at the base of the aerial pedestal where it joins the step to the higher roof section. In several parts corrosion had eaten through the steel roof. The T86 cabin is mainly of aluminium alloy, except for the steel roof section around the base of the aerial pedestal. It is assumed that steel was used as welding was required in fitting this roof section around the circular pedestal base. Repair of the corroded sections has yet to be carried out. The level of corrosion is not serious and does not warrant replacement of the roof, or any part of it.

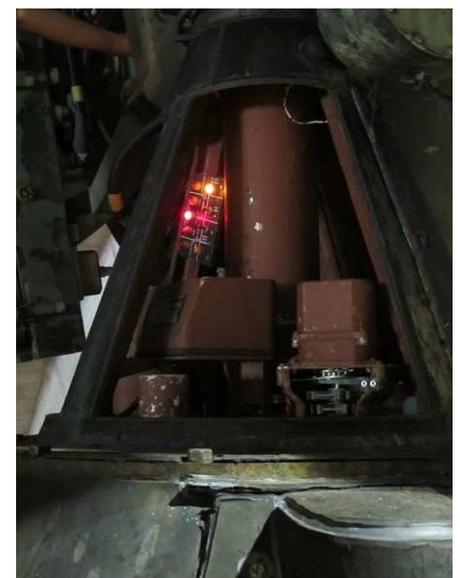
-24 Volts DC on the Aerial

Releasing the T86 aerial brakes requires two separate -24 Volts DC supplies from two power supplies, one in F Rack and one in the console – D Rack. The original power supplies were not serviceable as a visual inspection showed the large electrolytic smoothing capacitors had blown pressure seals and leaking dielectric. To provide the required DC power two commercially available 24 Volt power supplies were connected to the circuit on a temporary basis. Mains voltage was then connected to the 24 Volt power supplies, again on a temporary basis. When the two 24 Volt supplies were switched on, the roof safety switch and the aerial brake switches on the console applied, there were two separate 'clunks' from the aerial assembly as the bearing and elevation brakes were released for the first time in at least twenty two years.

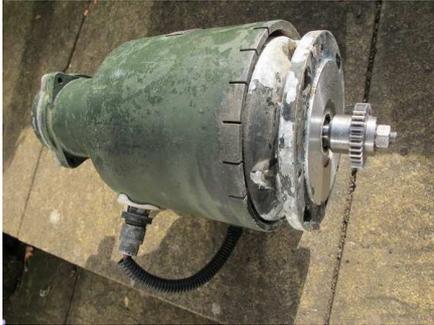
**T86 Elevation Motor after Removal and Cleaning**

Once the brakes were released the aerials could be moved in bearing but not in elevation! The suspected problem preventing the aerials from moving in elevation was the Elevation

Drive Motor. The motor, being exposed to the elements, was very likely corroded. The only way to establish this was to remove the elevation motor from the aerial assembly.

As soon as the elevation motor was removed and the aerial brakes released the aerials fell on their back, confirming that the elevation motor was seized and causing the lack of manual elevation aerial control.

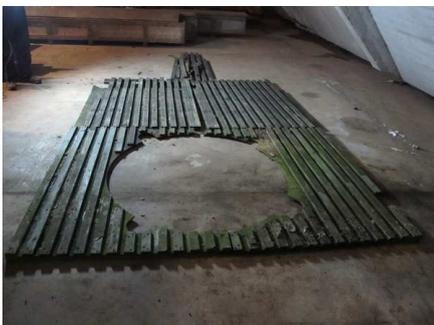
**T86 Roof Decking Laid Out after Removal**

The wooden roof decking had badly deteriorated due to its many years exposed to the weather. In parts the decking was completely rotten. Replacing the decking is a priority as access to the T86 roof is required for working on the corrosion to the lower roof level and the aerial assembly.

The cabin roof decking has been removed from the T86, leaving it in position would have posed a hazard.

it. The plan is to replace the decking without the plywood and the RFI sheet as the plywood is also rotten in places. The RFI sheet will be kept and possibly reinstated at some future date, if it can be removed from the plywood.

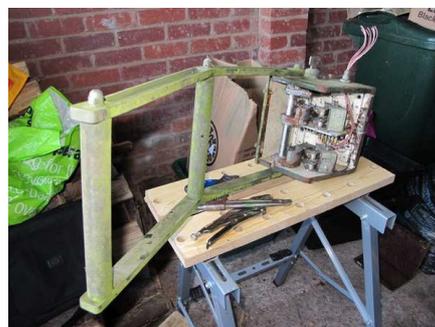
**Roof Ladder in the 'Workshop'**

The Castell Key for the roof safety switch was missing on BMPG's T86 when it was acquired. The Castell Key is used to lock the roof ladder in the safe position for servicing access to the radar roof.

In the photograph above the 'new' Castell Key is protruding from the top of the roof switch box.

Fortunately the BMPG had access to a derelict T86 which still had its Castell Key in position on the roof ladder. Neil Cartman took charge of salvaging the key and installing it in the BMPG's roof ladder switch box. Not a straight forward task as the switch mechanism also had to be changed.

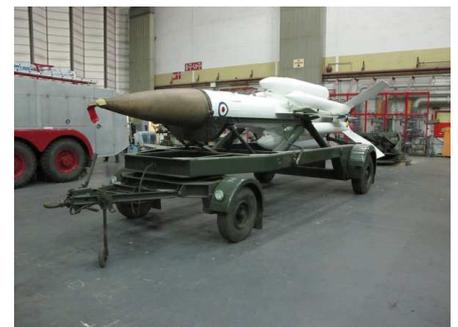
In the next issue of the newsletter it is hoped to have reports from various museums on their Bloodhound exhibits and from other Bloodhound restoration projects underway. Notable among these is the Flying Club at North Coates who are restoring MKI missile for display there. In the meantime here is photo of BACT's MKI missile on an original MKI missile trailer.

**MKI Missile on Trailer**

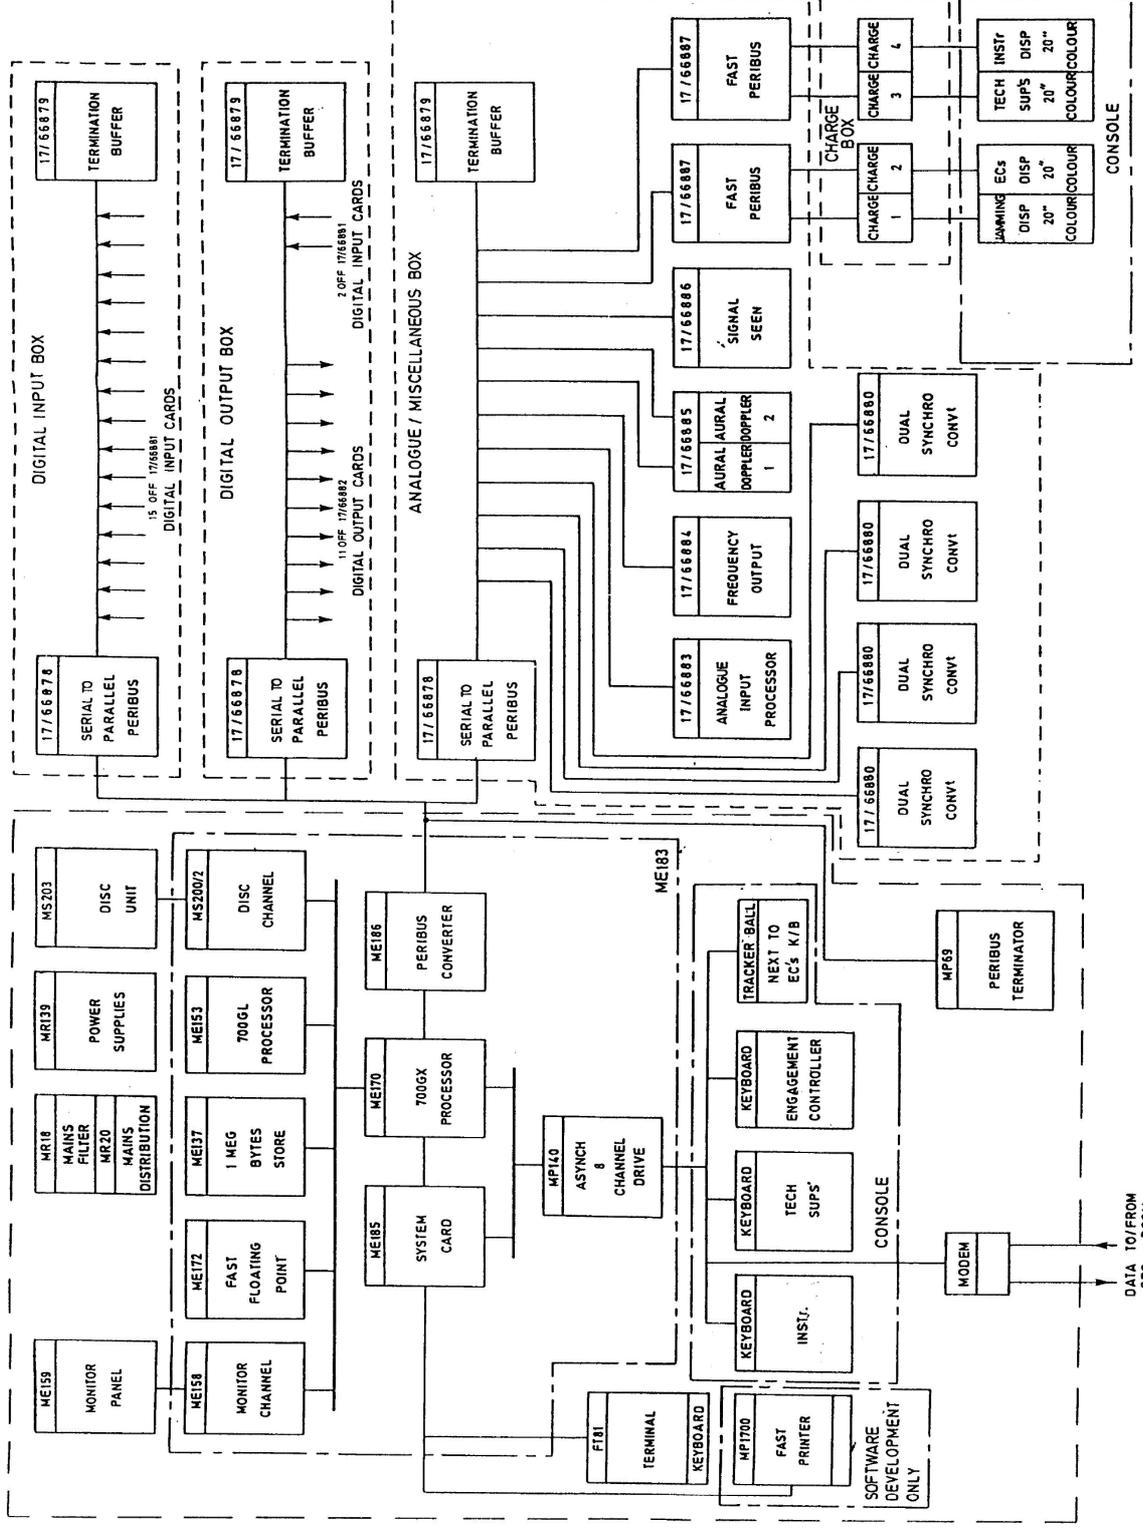
BMPG Newsletters refer to the various items in the LCP that go to make up the Argus 700 Computer System and Display Console. The following diagram is provided to show the layout of the Bloodhound MKII Simulator

I expect most readers will not be familiar with the MK2A LCP being restored. The MK2A LCP is the update standard carried out from 1986 onwards, by Ferranti, which replaced the original build MKII LCP's. The MK2A's were in operational service from 1986 until the last RAF Bloodhound squadron was disbanded in 1991. For reference; a diagram of the MK2A Argus 700 computer system is attached to this newsletter.
